Manhole Inspection Summary

Manhole # **S33CC_022MH**

Insp Date: **8/5/08 11:23 AM**

Location Address: **913 TYSON ST**

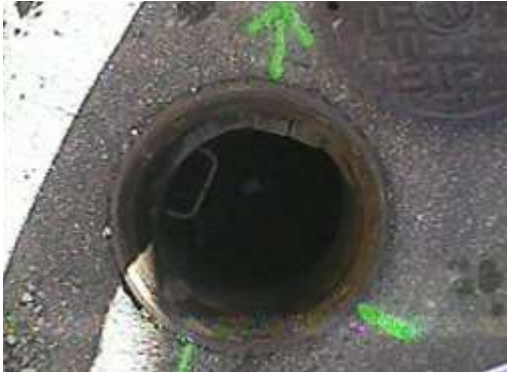
Top View

Frame Offset: **3** (in.) Condition: ☒ Sound ☐ Cracked ☐ Leaks

FRAME OFFSET

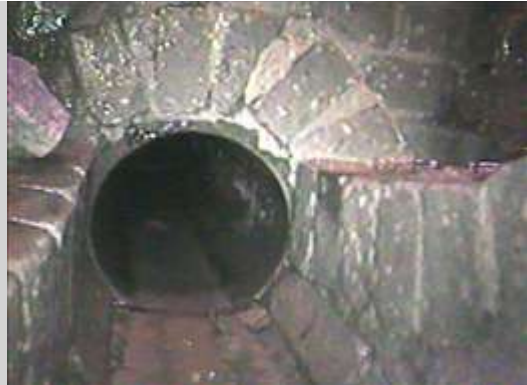
12 O'Clock Outflow

8 in. Circular Gravity Sewer
Pipe Out @ 12 O'Clock

Pipe Material: **Clay** ☐ Pipe Lined

Invert Depth: **10.05** (ft.) Flow Characteristics: **Slow**

Deposits: ☒ None ☐ Mud ☐ Sludge ☐ Debris ☐ Grease

Infiltration: **None** Pipe Seal Cond: **Sound**

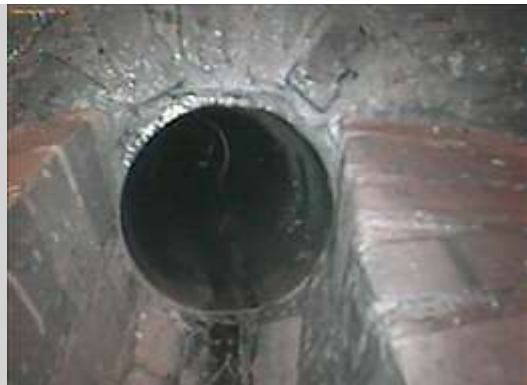
4 O'Clock Inflow

8 in. Circular Gravity Sewer
Pipe In @ 4 O'Clock

Pipe Material: **Clay** ☐ Pipe Lined

Invert Depth: **9.30** (ft.) Flow Characteristics: **Slow**

Deposits: ☒ None ☐ Mud ☐ Sludge ☐ Debris ☐ Grease

Infiltration: **None** Pipe Seal Cond: **Sound**

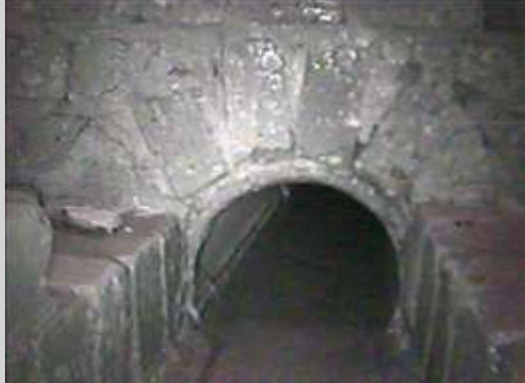
7 O'Clock Inflow

8 in. Circular Gravity Sewer

Pipe In @ 7 O'Clock

Pipe Material: **Clay** ☐ Pipe Lined

Invert Depth: **10.00** (ft.) Flow Characteristics: **Slow**

Deposits: ☒ None ☐ Mud ☐ Sludge ☐ Debris ☐ Grease

Infiltration: **None** Pipe Seal Cond: **Sound**
